LSU HEALTH SCIENCE CENTER

Project Program

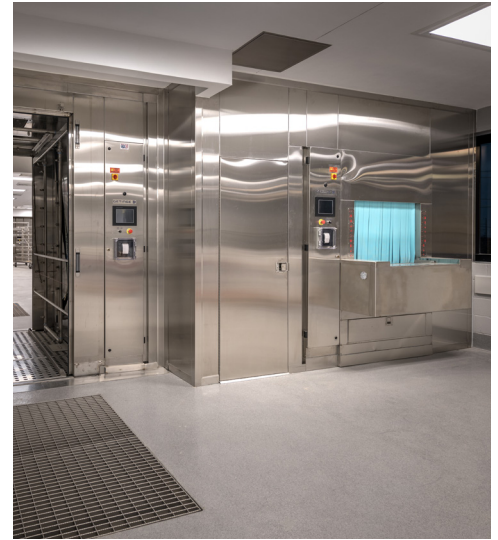
A 1' deep structural pit was inset to accumulate the run off from the vivarium's hydro-washer.

Within the vivarium is a large cage rack hydro-washer and sterilizer used for thorough, efficient cleaning of cages, racks, debris pans, and miscellaneous items used in the care of laboratory animals. This piece of equipment was inset in a large 1' deep structural pit to accumulate all the water from the cages. Due to the large amount of water from this scope item, extra waterproofing materials were installed between floors 3 and 4.

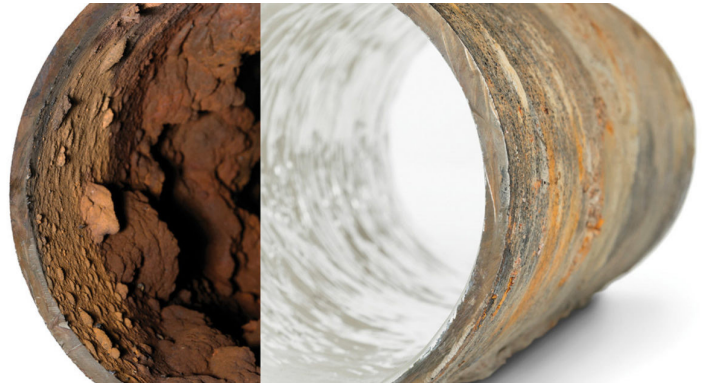
An Epoxy Brush Coating was applied in the pipes of the Vivarium's Cage Washing system to increase waterproofing, strength, and durability.

vivarium's drainage system, an Epoxy Brush Coating was applied to the pipes which fills pinholes and cracks to eliminate corrosion of animal care products over time.

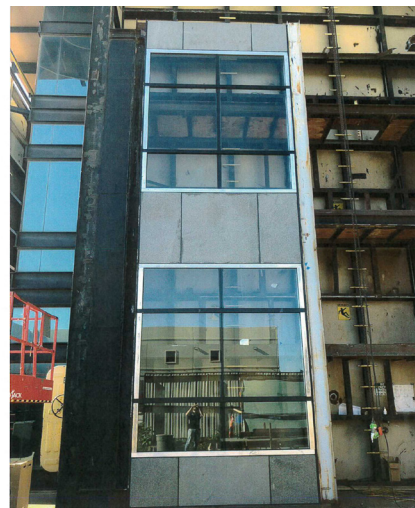
The exterior glass curtain wall system's performance was mocked-up and tested for wind and water penetration in Texas.

project, most notably the exterior glass curtain wall system. To ensure the exterior system was met its hurricane/wind rating it was tested by CCL (Construction Consulting Laboratory). This Texas-based company performed the curtain wall system testing and ensured its quality performance.

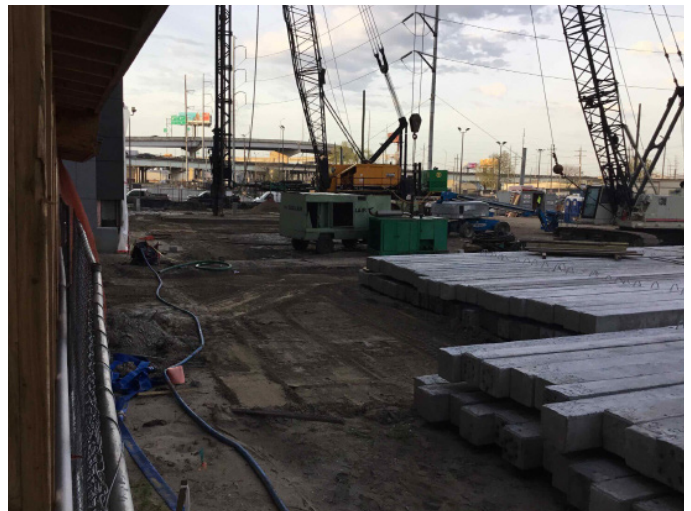
After the delay of contaminated soil, the team faced Covid-19 restrictions in March 2020 which impacted the progress of the CSRB building, starting with the pile driving activities.

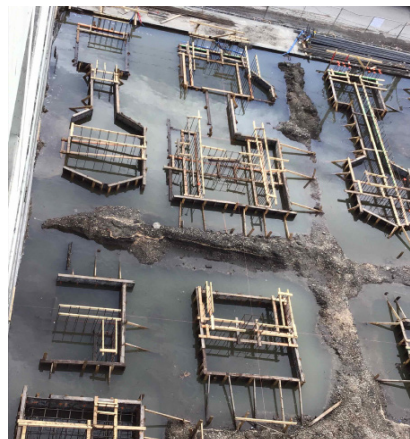
The site of the new central plant was flooded in July 2019, one of the many weather events that impacted the site.

This project was impacted by a total of 218 weather-delayed days. Some of the weather events resulted in major flooding in and around the project, one event in particular resulted in 13 cars being flooded. In addition to the weather days impacting the scheduled activities, they also took unforeseen resources away from the job to remove water from the flooded sites so activities could continue.
